Ice Jam Flood Assessment for the St. John River Basin, Aroostook County, Maine

Special Report 95-15

Cold Regions Research &
Engineering Laboratory

Prepared for
U.S. ARMY ENGINEER DIVISION, NEW ENGLAND

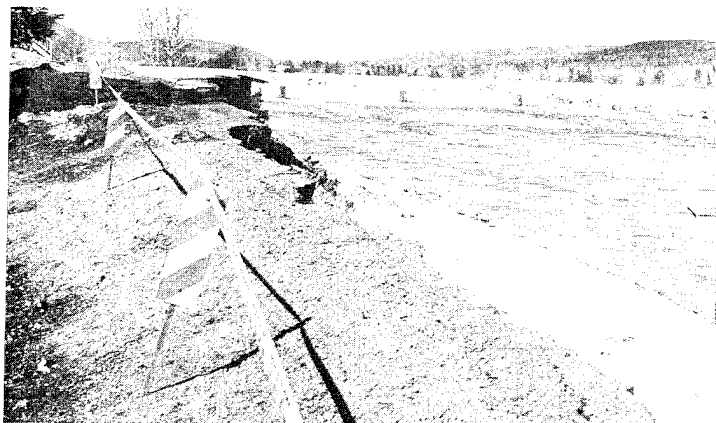
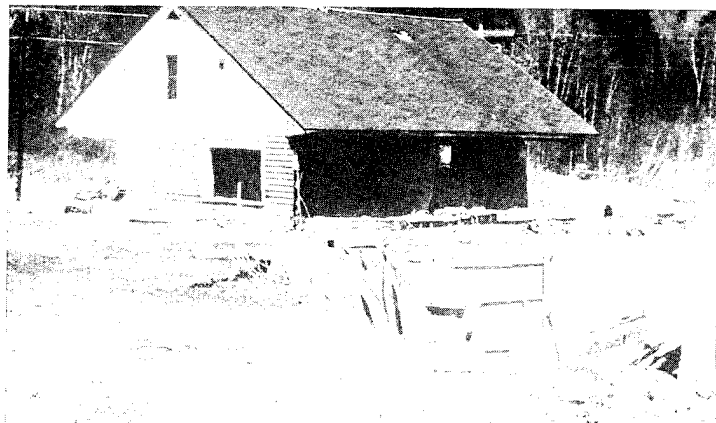
Figure 1. Ice jam damage in the town of Allagash, Maine, April 1991.

a. Bridge and road section destroyed.

b. Private home moved from foundation.

(1973–1992) (Table 1). Most recently, in the spring of 1991, devastating ice jam floods on the St. John River caused damage estimated at \$14,000,000. On 9 and 10 April 1991, the two bridges in the village of Dickey, located in the town of Allagash, 1000 ft of state highway and 11 houses were destroyed (Fig. 1) and an additional 22 houses were damaged. On 13–14 April, ice jam floods on the Aroostook River caused damage to shoreline, roads, 16 houses in the town of Fort Fairfield and properties in the village of Crouseville located in the town of Washburn.

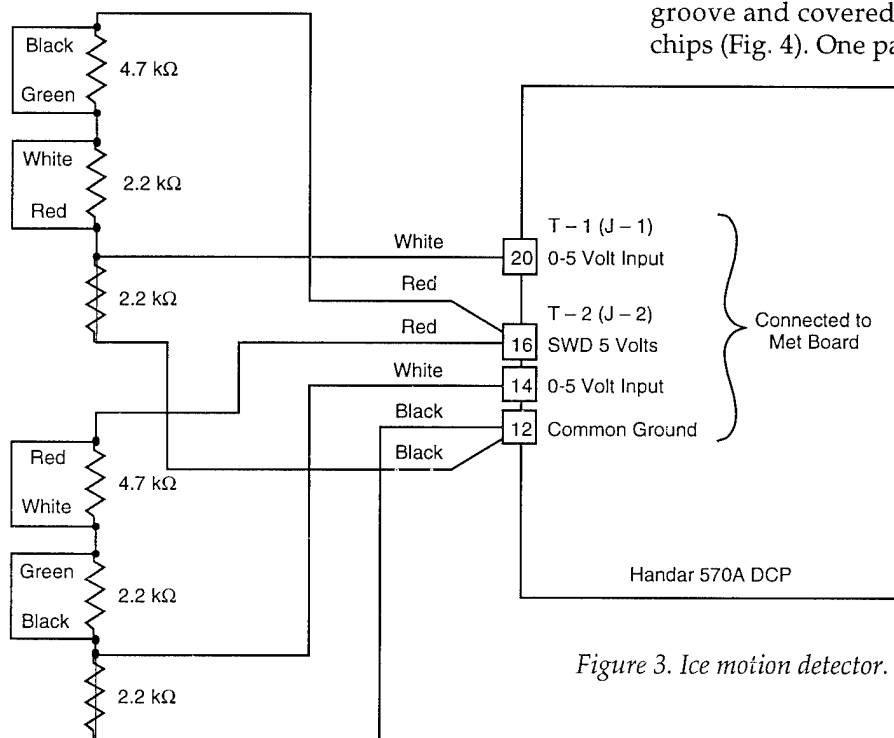
Figure 3. Ice motion detector.

bridge on the upper St. John River. Each sensor consisted of two pairs of electrical wires. Each pair, of different length, is joined at one end by a waterproof connection and at the other end is connected to a series of resistors, which in turn are connected to the USGS Nine Mile stream gaging station's Data Collection Platform (DCP). An electrical diagram for the system is shown in Figure 3. The voltage measured by the DCP determines if both pairs of wires are intact, if one or the other pair has broken, or if both pairs have broken.

A 4- to 6-in. deep groove was cut into the ice cover from the bank perpendicular to the river flow. Both pairs of wires were laid into the groove and covered with packed snow and ice chips (Fig. 4). One pair extended 100 ft outward,

the other 175 ft. This difference in length was introduced to account for the possibility that the ice may not break up simultaneously across the whole river width. We also felt that two pairs of wires per detector would improve their reliability, since there is always the possibility that one pair may be damaged by chafing of the protective insulation because of minor ice motion, or other causes.

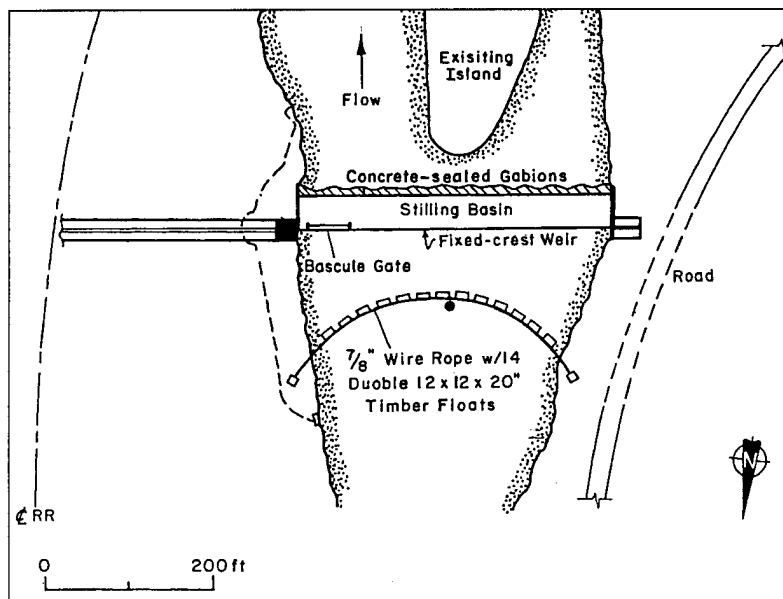
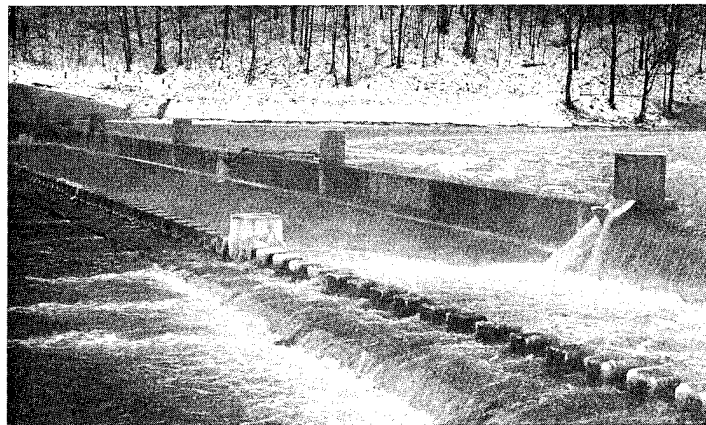
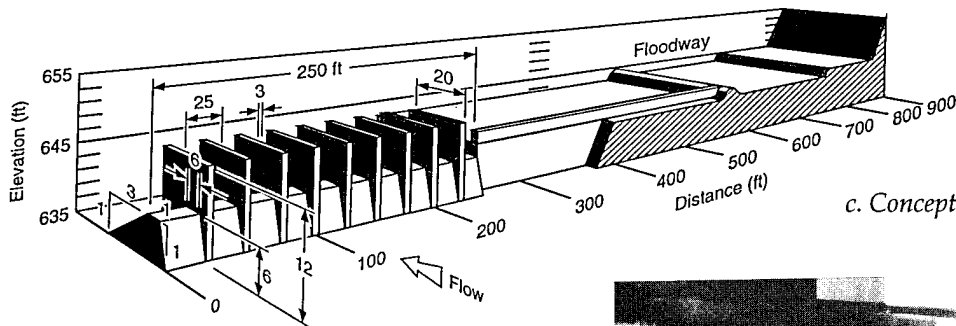
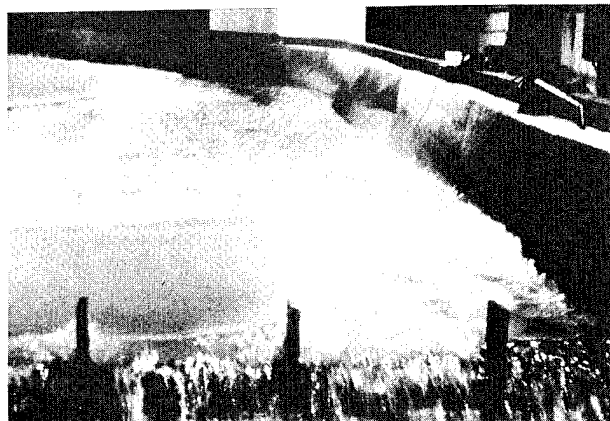
Figure 6. Examples of weirs or small dams.

Approximately 6 to 8 ft high, weirs either stabilize a naturally forming ice sheet or create a low velocity pool where an ice sheet will form. They also provide a local storage area to temporarily hold incoming brash ice during an upstream breakup. They can be equipped with ice-holding piers to enhance their ice-holding capacity, and with bascule gates to allow recreational navigation during the ice free seasons. Examples are the ICS on the Oil Creek, near Oil City, Pennsylvania, and a proposed ICS for Cazenovia Creek, near Buffalo, New York (Fig. 6).

a. General plan of Oil Creek ICS, Pennsylvania.

b. Oil Creek ICS in operation.

c. Concept of Cazenovia Creek ICS.

d. Hydraulic model of Cazenovia Creek ICS.

around an existing ice jam site, thereby reducing the water level behind the jam and consequent flooding. It, therefore, also reduces the water pressure head exerted on the jam, and delays jam failure. A bypass channel can be used alone, as was proposed at Port Jarvis, New York, or in conjunction with an ice control structure (e.g., Cazenovia Creek structure, Fig. 6c and d).

2. Ice control structures downstream of the Priestly bridge. Either a 6- to 8-ft high weir similar to the Oil Creek or Cazenovia Creek ICS, or a series of rock-filled cribs connected by modified ice booms could be built. It is estimated that such an ICS would alleviate all ice damage from the 500-year event at all locations downstream from the structure.

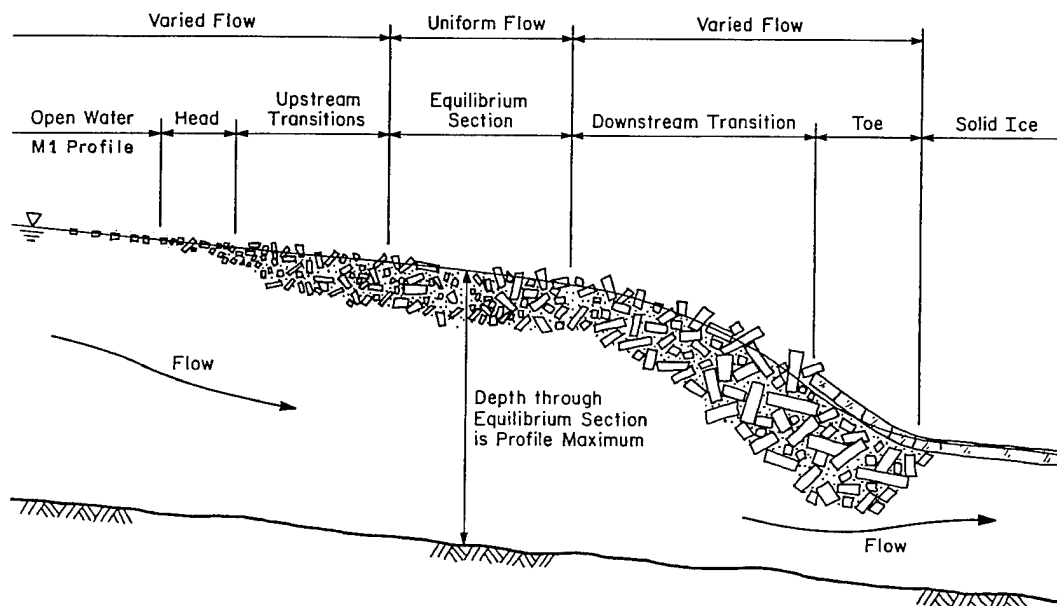
Figure 10. Longitudinal profile of a typical breakup ice jam.

the upstream end, or head, of the jam, flow depth again makes a transition towards the lower flow depths associated with the open water conditions upstream. The longitudinal profile of a typical fully developed breakup ice jam is shown in Figure 10.

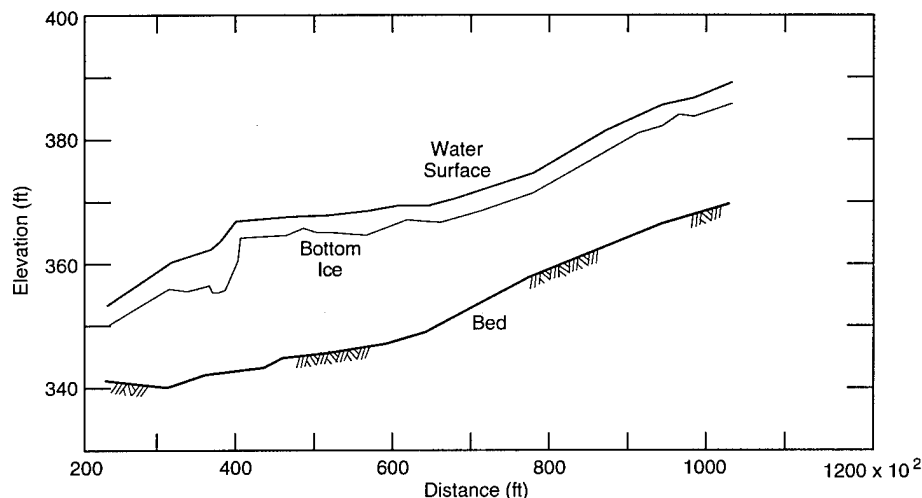
Figure 11. Water surface profile for an equilibrium ice jam on the Aroostook River between Fort Fairfield and Caribou dam.

Water surface profiles for the Aroostook River were calculated using the HEC-2 computer program (USACE 1990). This analysis was based on a verified open water HEC-2 data deck and downstream rating curve prepared by NED personnel. The original deck provided to CRREL

covered approximately 5 miles of the river, extending from river station 236+54 at the U.S.-Canadian border to river station 490+70. This original data deck was extended by CRREL to river station 1034+00, which is just below the dam in the town of Caribou, so that the relative effectiveness of alternative ice control options could be compared as described later. Cross-section data for the extended deck were derived from USGS 7.5-minute topographic maps. Manning's n values were retained from the original data deck. The extended portion of the data deck has not been verified against field data and should be considered only approximate.

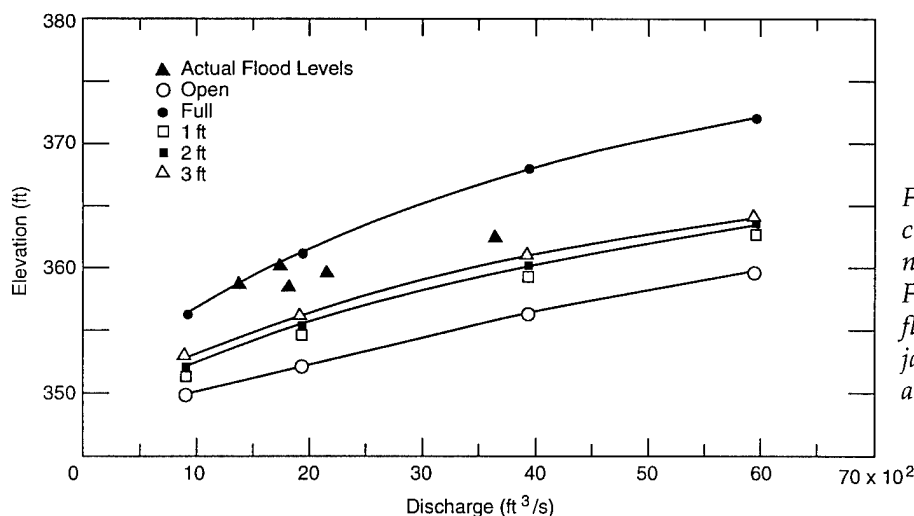
Figure 12 shows an ice-affected rating curve

Figure 12. Ice-affected rating curves of the Aroostook River, near Limestone Road bridge, Fort Fairfield. Shown are the flood levels reached during ice jams in 1932, 1936, 1940, 1973 and 1976.

developed for river station 402+84, which corresponds to the Limestone Road bridge. The curves represent open water, ice-covered and ice-jammed conditions in order of increasing stage. The figure shows the calculated ice-affected water levels for discharges up to a 25-year open water flood (60,000 ft³/s). It is unlikely, however, that an ice cover would remain intact for discharges much greater than 10,000 ft³/s or that a jam would remain stable for discharges as large as a 5-year open water flood (43,000 ft³/s). For the major ice-related floods reviewed in Table 3, peak stages for all but one were reached at discharges of no more than 23,000 ft³/s. The remaining flood, in 1976, had a discharge on the order of 37,000 ft³/s. A 2-year flood is on the order of 31,000 ft³/s. Prior to reaching a 5-year recurrence interval discharge, it is likely that any ice jam would release, and water levels would return to open water levels. Thus, the true rating curve would likely follow the curve for an ice cover of appropriate thickness up to a discharge

of 10,000 to 15,000 ft³/s, and would then increase to levels no greater than the equilibrium jam curve (depending on ice conditions and supply).

It must be reiterated that calculations assuming an equilibrium ice jam generate the maximum possible water surface elevation for a given discharge. Actual water levels are most often less. Lower actual water levels can be found at locations close to the toe of the jam where the jam may not be fully developed. If there are insufficient quantities of ice to form an equilibrium jam, the actual water levels will also be lower than computed. For example, the December 1973 ice jam was known to be only about 1/2 mile long, and could thus affect only a relatively short length of river.

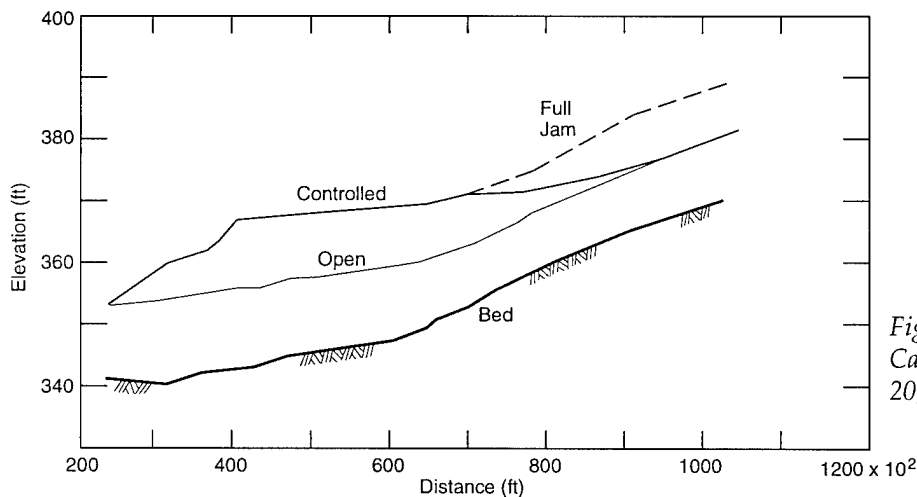
Figure 13. Possible effect of the Caribou dam as an ICS ($Q = 20,000$ ft³/s; $h_i = 28$ in.).

It is possible that the dam in Caribou acts as an ice-retaining structure during breakup. If so, the supply of ice to the jam at Fort Fairfield

would be limited to that ice present in the river between Fort Fairfield and the dam. The HEC-2 program with ice option was run for this case, for the same discharge of 20,000 ft³/s and with the additional assumption, supported by the field measurements and the calculations in Table 2, that the ice thickness averaged 28 in. The results of the computations are presented in Figure 13. With ice supply limited by the dam, we found that the jam should extend up to station 680, approximately, and that the jam backwater should merge with the open water surface profile at about station 950. Therefore, improvements to the dam to ensure that it acts as an ice-control structure would not be sufficient to alleviate ice jam flooding at Fort Fairfield. Additional mitigation means, upstream of Fort Fairfield and below the dam, would be required.

We again emphasize that in developing Figures 13 through 16 we assumed that the jams would be fully developed, a conservative assumption, and that ice volumes would correspond to a before-breakup ice cover thickness of 28 in. Depending on the actual thickness of ice formed in a given year and, especially, the extent of ice decay before breakup, the actual ice volumes, ice jam length and resulting water levels may be less.

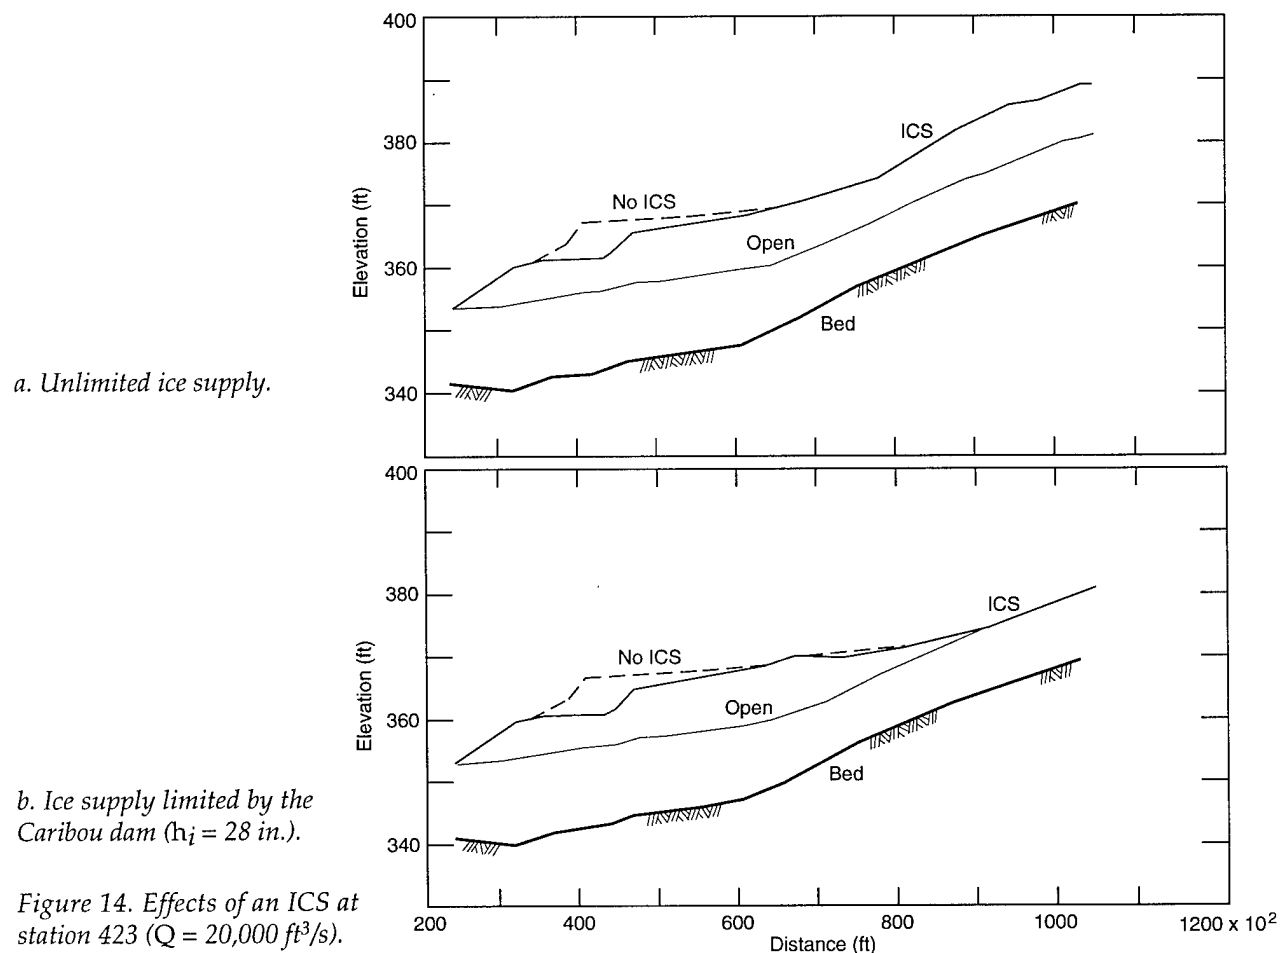
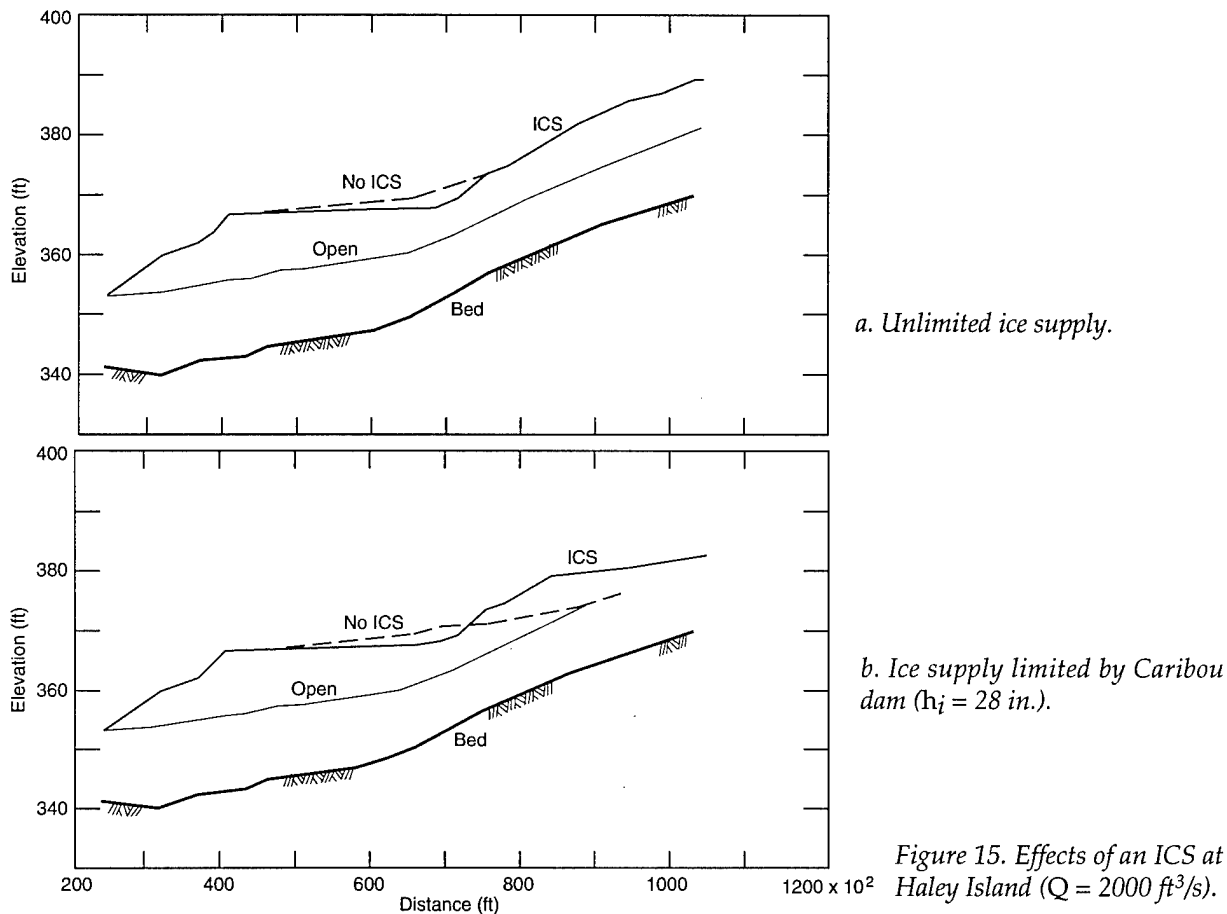
Figure 14a shows the effect of constructing an ICS at station 423+00, approximately 2000 ft upstream from the Limestone Road bridge for the case of unlimited ice supply. Figure 14b shows the effect of the same ICS when the ice supply is limited by the Caribou dam and for an ice thickness of 28 in. Both figures show that the water level is reduced by as much as 6 ft between about stations 330 and 423. Upstream of the ICS

the water level is initially reduced by about 2 ft, but at about station 630 it goes back to the level without the ICS.

The effects of an ICS at station 656 in the vicinity of Haley Island are shown in Figure 15 for the two cases of unlimited ice supply and ice supply limited by the Caribou dam. The figures show no discernible effect of the ICS on the water level below station 500, and a maximum drop of about 3 ft in the water level at the ICS location. For the case of unlimited ice supply, the water level upstream of the ICS goes back to the full jam value at about station 740. On the other hand, if the Caribou dam indeed limits the downstream ice supply, the ICS at Haley Island leads to an increase in upstream water level (Fig. 15b) because it retains all the ice between Haley Island and the dam.

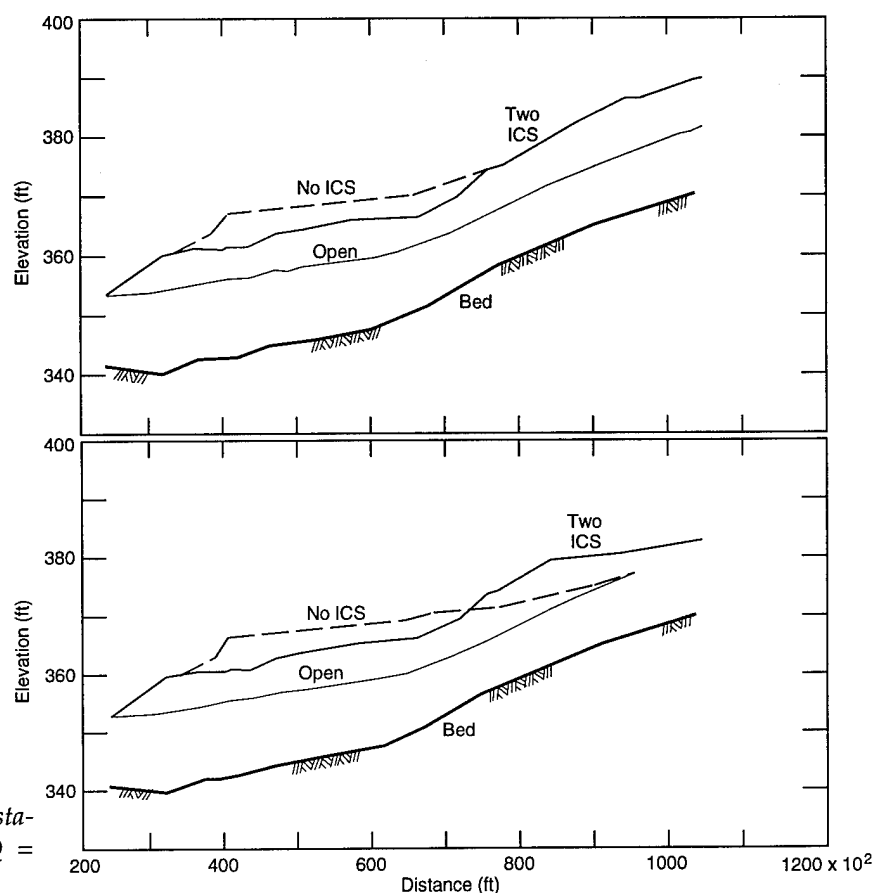
Figure 16. Effects of ICSs at both station 423 and Haley Island ($Q = 20,000 \text{ ft}^3/\text{s}$).

b. Ice supply limited by Caribou dam ($h_i = 28$ in.).
